BUILDING-STRUCTURE INVENTORY FORM

DIVISION FOR HISTORIC PRESERVATION  
NEW YORK STATE PARKS AND RECREATION  
ALBANY, NEW YORK (518) 474-0479

261 Wall Street  
Corning, New York

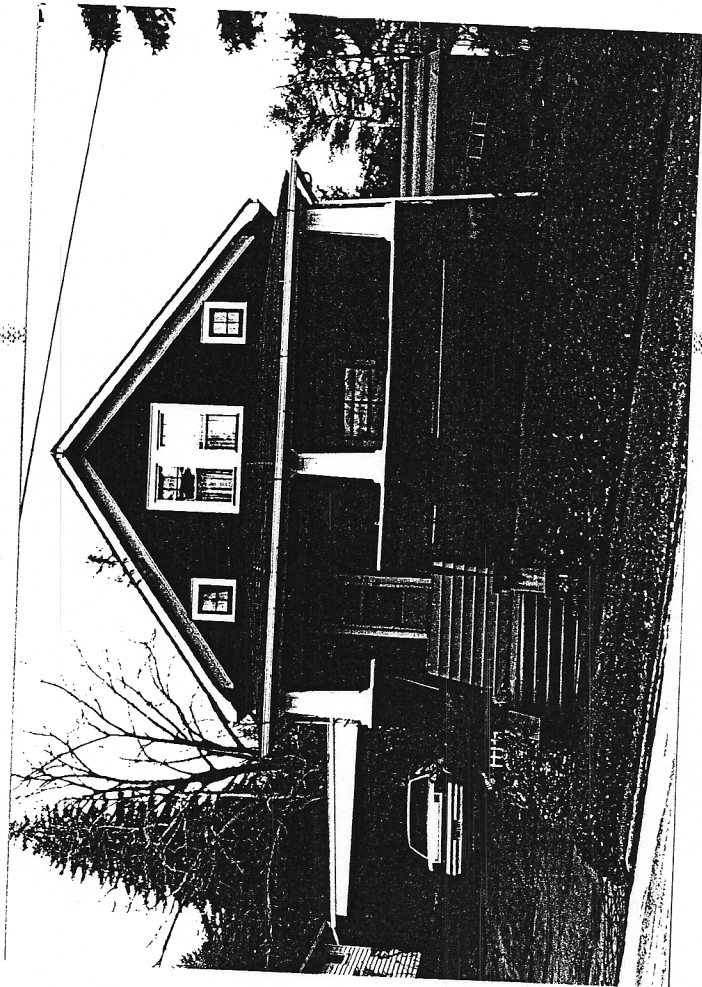
261 Wall St.

This one-and-a-half-story home has an raised foundation of concrete block supporting walls covered with wood shingles. The main entrance to the house is located on the east facade. The closed porch has three battered piers to support the low-pitched roof, and access to the house is up a small flight of stairs and through the southernmost bay of the porch. Centered under the porch in the northernmost bay is a large double-hung sash with two-over-two lights. Above the roof of the porch on the principal east facade are three windows. Centered under the gable is a pair of double-hung sashes with four-over-one-lights. Flanking this pair are small windows, approximately the size of one light of the central window, which are divided into four lights. The remaining three facades of the house are similar in scale and materials. The north facade has three bays, with paired windows in the central bay with single windows to either side. The easternmost bay on the north facade is an oriel window. The attached carport, made of sheet metal, projects from the south facade.

The roof of the house is covered with asphalt shingles. There are two dormers found within the roof, one on the south facade and one on the north facade. Each dormer has a pyramidal roof and a set of three windows. There is also a chimney located on center within the roofline of the house. A shed is located northwest of the house on the property; the outbuilding has the same materials as the house and is built with a simple gable form.
