CONTINUATION SHEET, Page 1

209-211 Walnut Street

Corning, New York

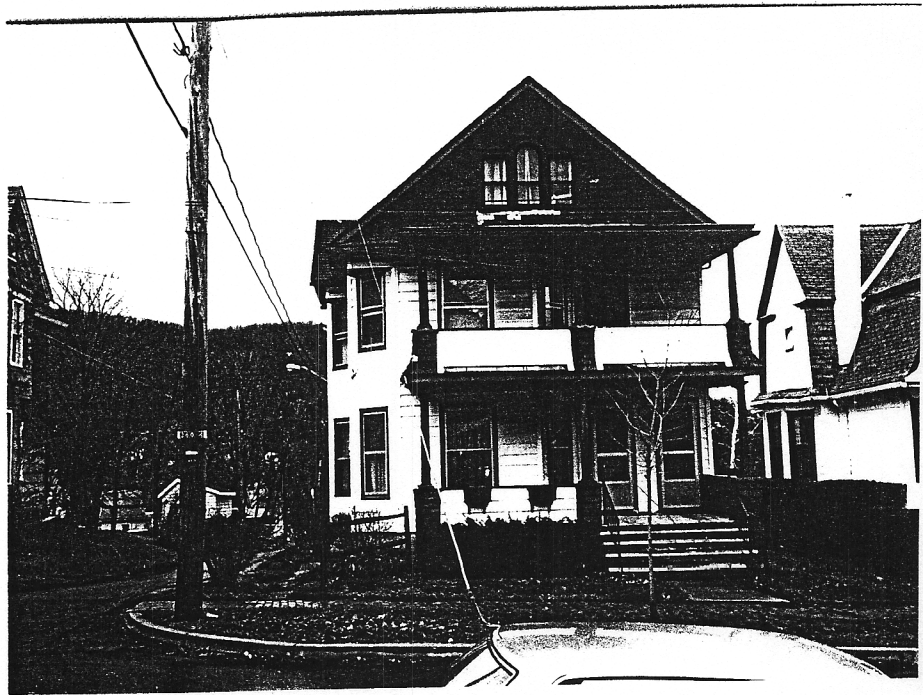
209 - 211 Walnut

This two-and-a-half story home is designed in the Queen Anne Style of architecture. In their book, A Field Guide to American Houses, the McAlester's refer to this as a cross-gabled example of the style with "Free Classic" detailing. The house exhibits many features associated with this style, such as the full width front gable with a lower cross gable in the rear, both of which have classical detailing.

Both the first and second stories of this home are covered in vinyl siding, the gable ends on the third story are clad in a patterned wood shingle design and also has a Palladian window. There is a bay window which extends on both the first and second stories of the primary facade. The two primary entrances, to either apartment, are recessed to the north side of the facade under the full-width, two-story front porch. The porch is supported by stylized column-like posts, the balustrade appears to have been enclosed. There is a chimney located in the center of the house.

This house sits on a partially raised basement which is made of poured concrete.
