**BUILDING-STRUCTURE INVENTORY FORM**

213-215 Walnut Street

Corning, New York

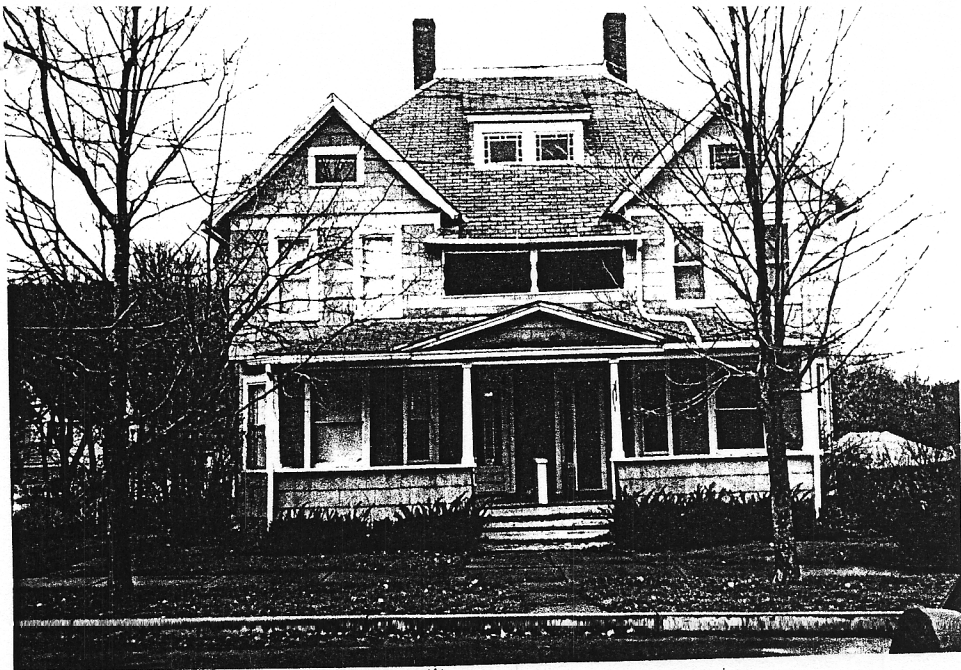
↳ 213-215 Walnut

This two-and-a-half story house is designed in the Queen Anne Style of architecture. In their book, A Field Guide to American Houses, the McAlester's would refer to this house as a "Free Classic" example of the style. Features typical of the Queen Anne style which are exhibited in this house include the steeply pitched hipped roof and lower front gables, and symmetrical primary facade.

This house is finished with asbestos siding, not original to the house. There are bay windows on the first story of each gable front and a full-width, one-story porch. This porch is supported by stylized column-like posts, the balustrade has been enclosed in and a pedimented entryway. On the second story of the house there is a recessed porch located between the lower cross gables, which has turned posts. There are small gable top windows in each gable top and a dormer on the hipped roof; both of these have Queen Anne sash windows. There are two chimneys on either side (north and south) of the structure.
