BUILDING-STRUCTURE INVENTORY FORM

- 1. BUILDING NAME(S):
- 2. COUNTY: Steuben TOWN/CITY: Corning VILLAGE:
- 3. STREET LOCATION: 236 Walnut Street
- 4. OWNERSHIP: a. public [] b. private [X]
- 5. PRESENT OWNER: Myles M. Mathieu ADDRESS: Same as above
- 6. USE: Original: Private Residence Present: Private Residence
- 7. ACCESSIBILITY TO PUBLIC: Exterior visible from public road Yes[X] No []
Interior accessible: Yes [] No [X] Explain: Private Residence

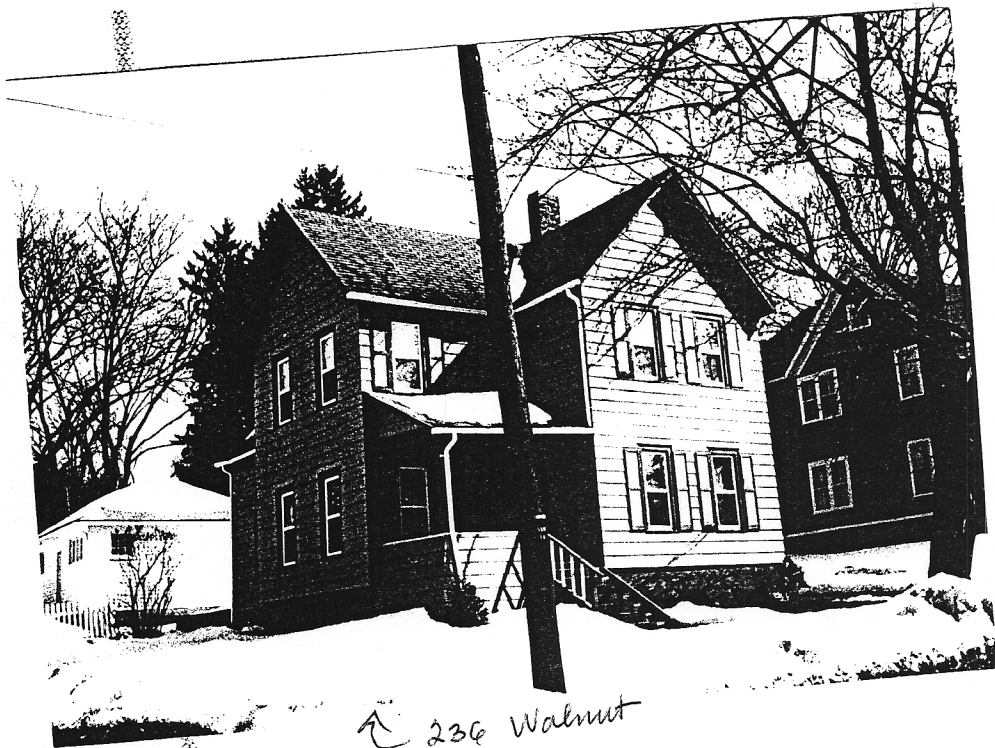
↑ 236 Walnut

The main (west) facade is dominated by a projecting gable wall covering the southern half of the facade. There are two sets of one-over-one double-hung sash on the gable wall, one on each story. Adjacent to the gable wall, and in the reentrant angle formed by the ell, is a one story porch with a shed roof covering the northern half of the facade. A slender wooden post supports the corner of the porch, resting on an enclosed railing. The entrance is on the west facade, set in the reentrant angle, and near the corner of the projecting gable wall. Between the entrance and the northwest corner of the facade there is a one-over-one double-hung window. The arrangement of windows on the west gable wall is echoed on the north and south gable walls.

The house is clad with clapboard siding, and has a coursed stone foundation parged with poured concrete. The structure has an asphalt roof.
