BUILDING-STRUCTURE INVENTORY FORM				FOR OFFICE USE ONLY		
DIV	ISION FOR HISTOR	IC PRESE	TRVATION	UNIOUE SITE	UNIOUE SITE NO	
ME	W YORK STATE PAR	SKS AND	PECDEATION	QUAD		
ALE	BANY, NEW YORK (	518) 474-(	0479	DEVIED		
				NEG. NO		
JOY	JR NAME: Gene Gre	ger		DATE: Fall 10	DATE: Fall 1993	
JUY	JR ADDRESS: 106 W	V. Sibley F	Hall, Ithaca, NY			
UKC	GANIZATION (if any)	: Preserva	ation Planning Wo	orkshop, Cornell Univ	(007) 233-4331 versity

CONTINUATION SHEET, Page 1 264 Walnut Street Corning, NY

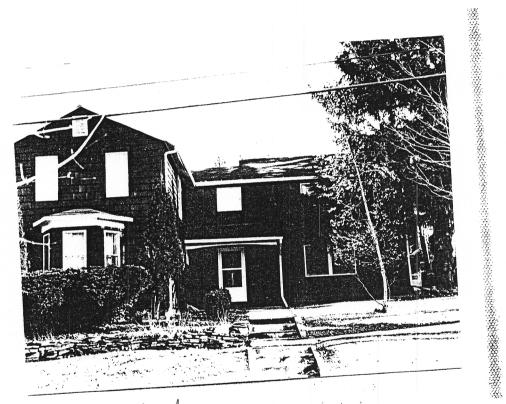
264 Walnut

This two-story house has a gable-front-and-wing shape. The gable-front wing forms the north side of the house and features a single-story bay window. The second wing intersects the first at the northeast corner of the house and continues south. The south half of this side-gable wing is larger than the north half and projects out of the east facade. A small single-story shed roof covers the entranceway located in the corner formed by the two wings. An end-wall concrete block chimney is situated on the south facade.
