BUILDING-STRUCTURE INVENTORY FORM

YOUR NAME: John R. Steinmeyer
YOUR ADDRESS: 106 W. Sibley Hall, Ithaca, NY
ORGANIZATION (if any): Cornell University

- 1. BUILDING NAME(S):
- 2. COUNTY: Steuben TOWN/CITY: Corning VILLAGE:
- 3. STREET LOCATION: 164 Cedar Street
- 4. OWNERSHIP: a. public[] b. private [X]
- 5. PRESENT OWNER: August V. Titi ADDRESS: 570 W. Third Street
Corning, NY 14830
- 6. USE: Original: residence Present: residence
- 7. ACCESSIBILITY TO PUBLIC: Exterior visible from public road: Yes[X] No[]

CONTINUATION SHEET, Page 1
164 Cedar Street
Corning, New York

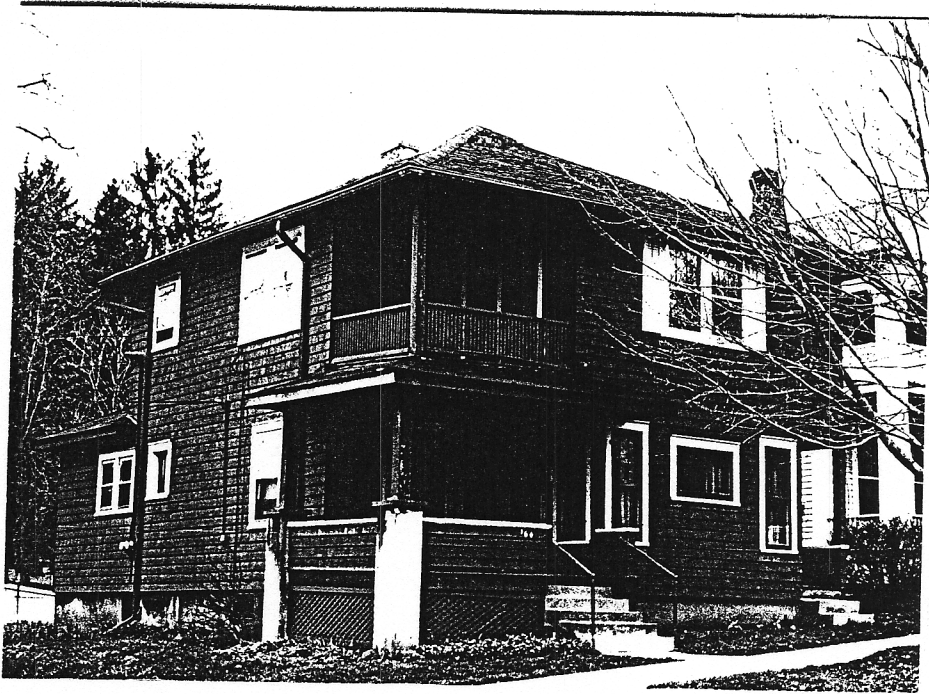
164 Cedar

This duplex is designed in the Craftsman style of architecture. The structure's identifying features, as noted in A Field Guide to American Houses (McAlester), include: block-like massing of the main house and its secondary design features; informal and asymmetrical placement of windows; a low-pitched pyramidal roof with eave overhangs; and corner porches with square piers on both stories of the principle facade. The walls are clad with square shingles, and a balustrade ornaments the second-story porch.
