CONTINUATION SHEET, Page 2

131 West 5th Street
Corning, New York

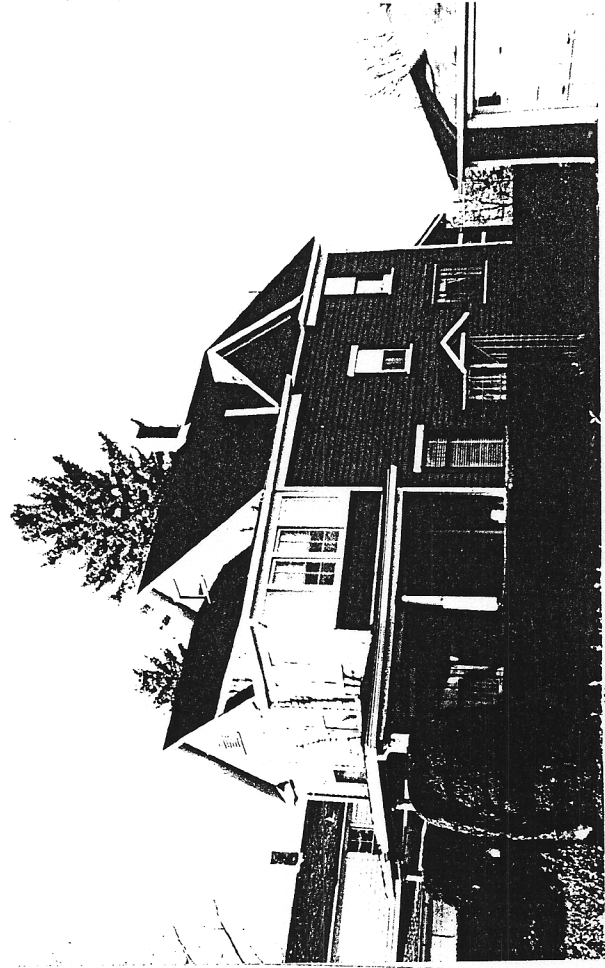
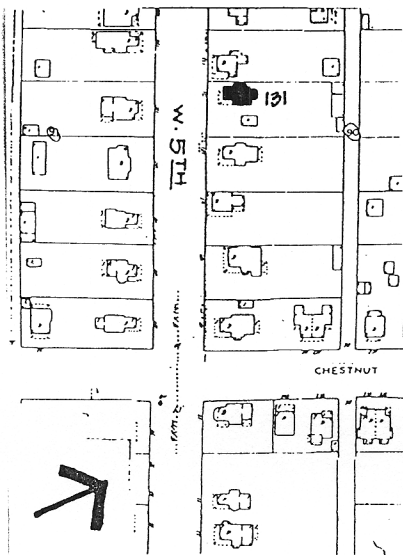
131 West Fifth

The residence has two-and-a-half-stories. Contiguous gables are found on the south (main) facade. The gabled section of this residence projects out toward Fifth Street. Square windows are centered in the gable ends. The fenestration is asymmetrical in all facades and the windows are one-over-one double-hung sash, six-over-one double-hung sash and six pane windows (in the latest addition). A gabled hood covers an entry stoop located on the east facade. A wall dormer without window projects out from the same facade. A one-story canted bay window projects from the west side of the house. The residence is sided in clapboard. The roof is made of asphalt shingles and a brick chimney is centered atop the roof.

The foundation is made of stone and covered with stucco.
