BUILDING-STRUCTURE INVENTORY FORM

- 1. BUILDING NAME(S): _____
- 2. COUNTY: Steuben TOWN/CITY: Corning VILLAGE: _____
- 3. STREET LOCATION: 137 East First Street
- 4. OWNERSHIP: a. public b. private
- 5. PRESENT OWNER: Wm. O'Hara ADDRESS: 137 East First Street
- 6. USE: Original: residence Present: residence
- 7. ACCESSIBILITY TO PUBLIC: Exterior visible from public road: Yes - No
Interior accessible: Explain not private residence

CONTINUATION SHEET, Page 1
137 East First Street
Corning, New York

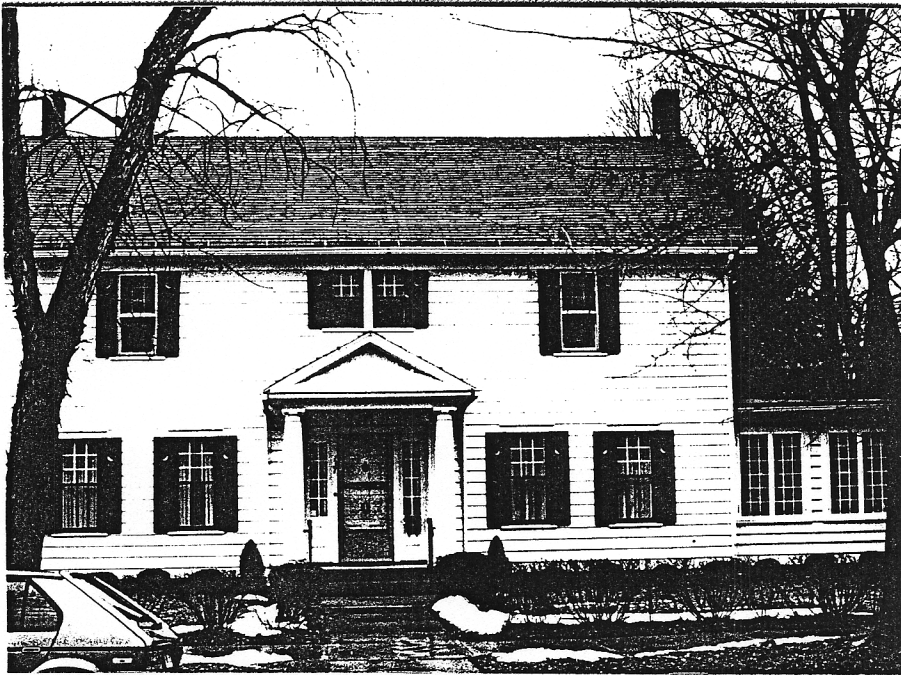
↖ 137 East First

This structure is clad in horizontal wood clapboards. The main (south) facade is basically symmetrical although there is a side porch on the east end. The porch is a common feature of Colonial Revival Style. The central doorway is emphasized by a pedimented portico, with fluted Doric columns supporting the outer corners and fluted pilasters to either side of the door. The windows are nine-over-one-light double-hung sash, with the following exceptions: the small paired window above the entrance has six-over-one double-hung sash, and the porch windows are multi-light casements. The main facade also features shutters with quarter moon cut-outs. The three secondary facades are much simpler, with few decorative elements.
