BUILDING-STRUCTURE INVENTORY FORM

- 1. BUILDING NAME(S): Christ Episcopal Church Parish House
- 2. COUNTY: Steuben TOWN/CITY: Corning VILLAGE:
- 3. STREET LOCATION: 33 East First Street
- 4. OWNERSHIP: a. public [] b. private [X]
- 5. PRESENT OWNER: Christ Episcopal Church ADDRESS: 33 East First Street, Corning, NY 14830
- 6. USE: Original: Ecclesiastical Present: Ecclesiastical
- 7. ACCESSIBILITY TO PUBLIC: Exterior visible from public road: Yes [X] No []
Interior accessible: Yes [] No [X] Explain: Private

33 East First Street - Christ Episcopal Church Parish House
Corning, New York

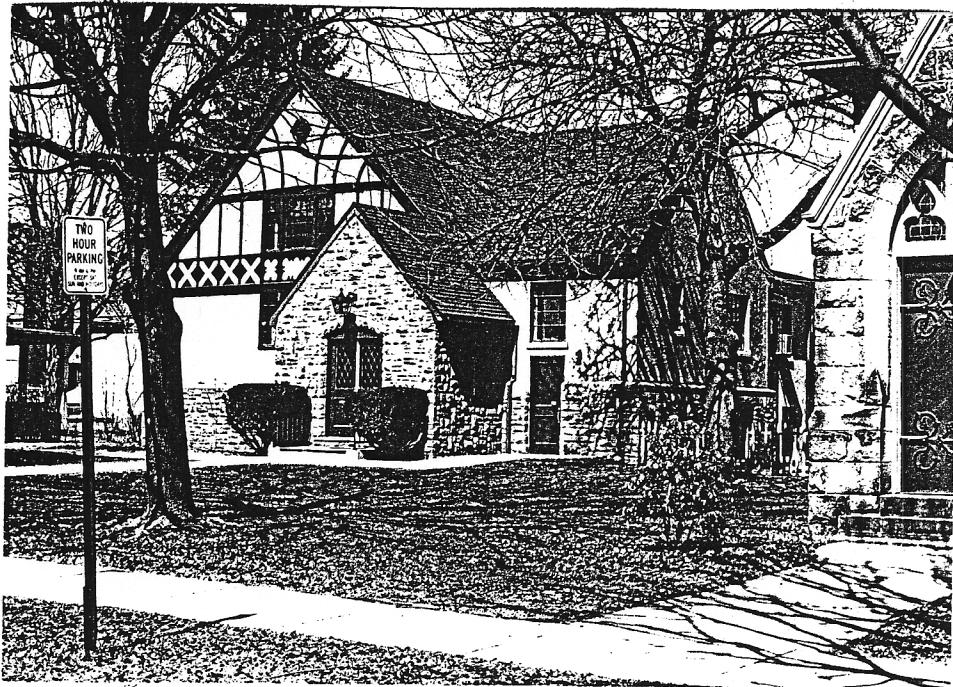
33 East First ↗

The Parish House has a broad street-facing gable with a cross gable extending to the east. The southern (front) facade has a projecting gabled bay and half timbering as its dominant features. The gabled bay is constructed in stone and serves as the main entrance to the Parish House. Offset on the front (south) facade, this bay has double door with diamond pane sash. The broad gable of the southern facade features half timbering typical of the Tudor Revival Style. The walls of the first and second stories have been stuccoed. The structure rests on a random ashlar foundation which rises five feet from the ground level and is topped by a stone watertable. The Parish House features single and tripled steel casement windows.
