BUILDING-STRUCTURE INVENTORY FORM

- 1. BUILDING NAME(S): Christ Episcopal Church
- 2. COUNTY: Steuben TOWN/CITY: Coming VILLAGE:
- 3. STREET LOCATION: 41 East First Street
- 4. OWNERSHIP: a. public [] b. private [X]
- 5. PRESENT OWNER: Christ Episcopal Church ADDRESS: 33 East First Street, Coming, NY 14830
- 6. USE: Original: Ecclesiastical Present: Ecclesiastical
- 7. ACCESSIBILITY TO PUBLIC: Exterior visible from public road: Yes [X] No []
Interior accessible: Yes [] No [X] Explain: Private

CONTINUATION SHEET, page 1
41 East First Street - Christ Episcopal Church
Corning, New York

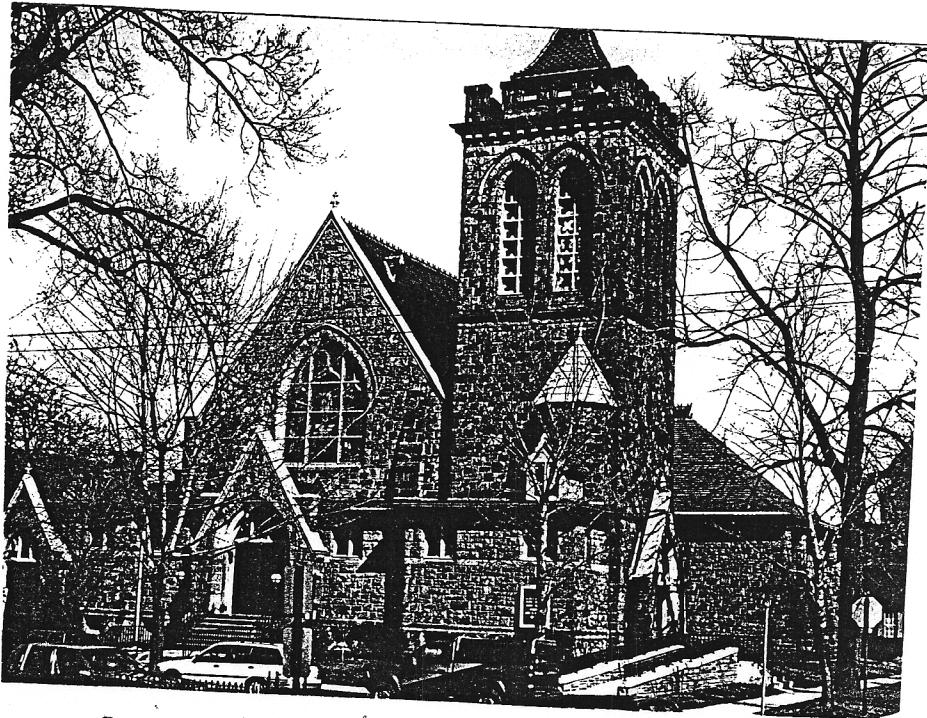
Episcopal Church 41 East First

Designed in the ecclesiastical Gothic Style, Christ Episcopal Church was patterned after English country churches with steeply pitched roof, entrance porches, buttressed walls and a large tower. The style has also been described as Norman Gothic.

The nave of the church runs in a north - south direction along Cedar Street with a lower east - west transept completing the cruciform plan. The apse is located to the north and the main entrance is located on the First Street elevation, both containing elaborate stained glass windows.

A massive three-story tower is attached to the nave at the southeast corner structure creates the focal point of the church. Lancet windows with stone tracery are featured in the upper portion of the tower as well as crenelated parapet and a tiled hipped roof which supports a cross finial at the peak.

The roof is covered in terra cotta tiles with crest tiles along the gable ridge. Louvered vent dormers are also visible along the east and west slopes of the nave roof. The building is constructed entirely of random ashlar Antrim stone which has a grayish cast. Other notable features of the building include steeply pitched entrance porches, drip moldings, buttressed

18. OTHER NOTABLE FEATURES OF BUILDING AND SITE (CONTINUED):
walls, a chimney stack on the west side of the apse, and clearstory windows that project through the through the eaves along the nave.
