**BUILDING-STRUCTURE INVENTORY FORM**

ORGANIZATION (if any): Preservation Planning Workshop, Cornell University

- 1. BUILDING NAME(S):
- 2. COUNTY: Steuben TOWN/CITY: Corning VILLAGE:
- 3. STREET LOCATION: 14 East Fourth Street
- 4. OWNERSHIP: a. public [ ] b. private [X]
- 5. PRESENT OWNER: Mark and Lesley Robinson ADDRESS: 14 East Fourth Street
- 6. USE: Original: Residence Present: Residence
- 7. ACCESSIBILITY TO PUBLIC: Exterior visible from public road: Yes [X] No [ ]  
Interior accessible: Yes [ ] No [X] Explain: Private residence

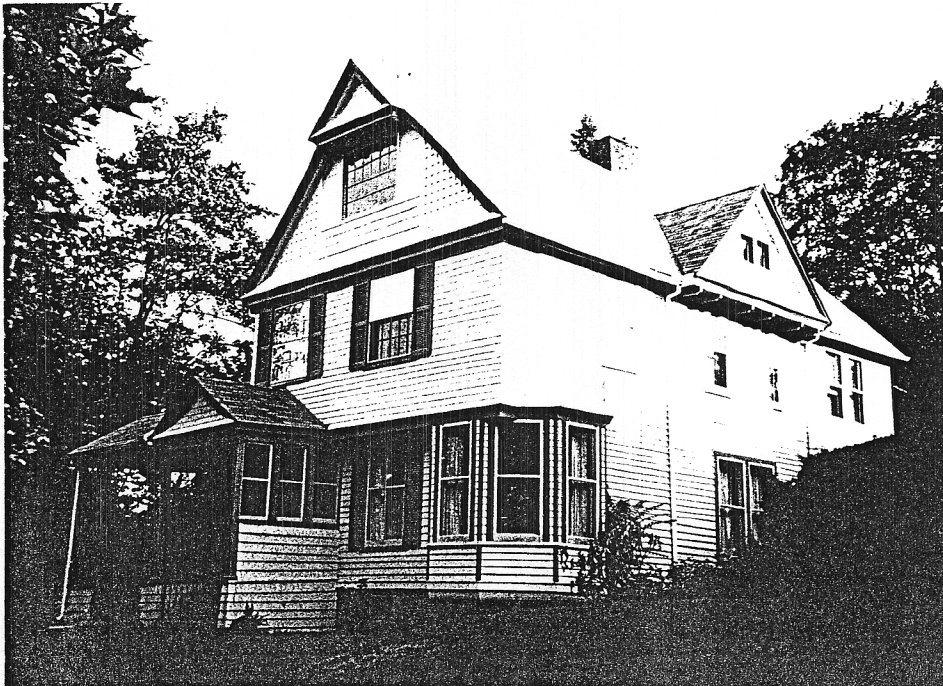
The plan of 14 East Fourth Street is basically square, with a one-story front/side projecting porch. The steeply pitched roof is the most prominent feature indicative of the Queen Anne Style. The asphalt shingled roof is dominated by a main gable constructed with a north/south orientation, intersected by a series of cross gables. Supporting the western corner of the north wall is a one-story cut-away bay window consisting of three one-over-one, double-hung sash. The northern portion recedes under the corner and the eastern portion projects from the east wall. This is a device used to create lively facade, where the Queen Anne Style attempts to avoid smooth facades. The clapboarded and textured wood surface of gable-end is highlighted by a large window consisting of twenty-four panes. The window is crowned by a tip of the gable end which projects even further than the main gable-end and is supported by small brackets. The second story north facade fenestration consist of two large assymetrically placed windows also consisting of twenty-four panes. The front entry door is highlighted by a gabled assymetrical projecting porch which is located on the eastern portion of the north facade. The gable end are finished with clapboard, and the western portion of the porch is enclosed with three one-over-one sash. The balustrade has been replaced by a wrought iron railing, and the skirting is enclosed with clapboard. The east and west facades are constructed with sloping, projecting gable ends supported by brackets and installed with two small windows. The first story of the east facade is detailed with two sash which are surrounded by decorative wood which crowns two small sash below.
