BUILDING-STRUCTURE INVENTORY FORM

YOUR NAME: Nicole Stull                      DATE: Fall 1993  
 YOUR ADDRESS: 106 W. Sibley Hall              TELEPHONE: (607)255-4331  
 ORGANIZATION (if any): Cornell University, Preservation Planning Workshop

91 West Fourth Street  
Corning, New York

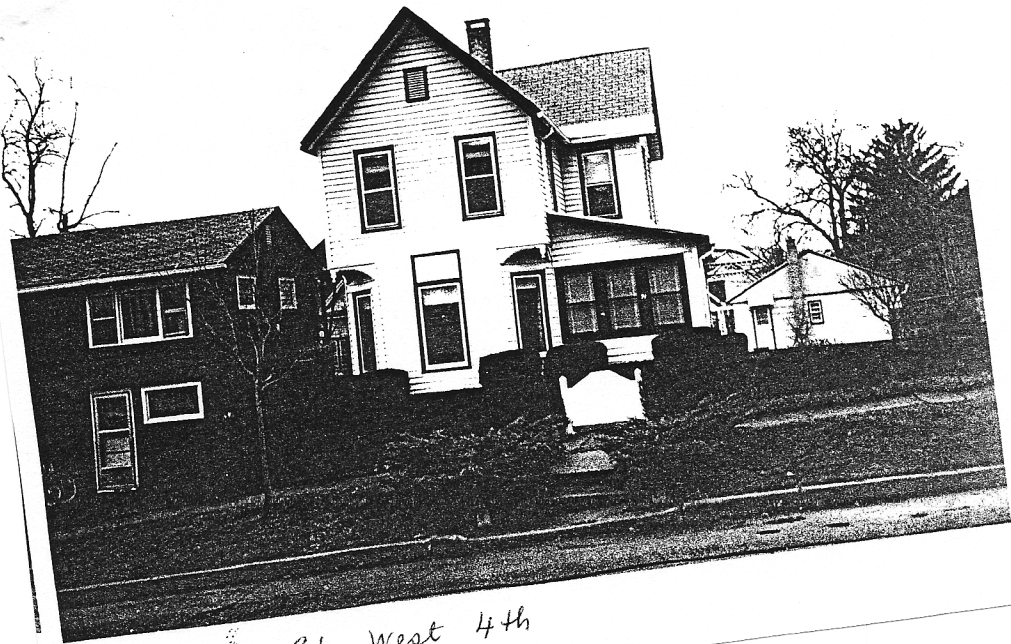
31 West 4th

This two-story house is built in the Queen Anne Style of architecture and exhibits many features associated with this style. These include steeply pitched cross gables with an asymmetrical front facade. This facade consists of a gable front with a one-story porch projecting from the east side. The architectural details of the structure are also consistent with the Queen Anne Style.

The house is covered in vinyl siding. The front (south) projecting gable features a bay on the first story level which has canted edges with decorative lace-like brackets and a central window on the main plane of the facade. The second story has two evenly-spaced windows. The main entrance is located on the east side of the structure, accessed through the screened-in porch. One unique features of the house the carved wood molding, located directly above the central window on the first story of the south gable front.
