BUILDING-STRUCTURE INVENTORY FORM

- 1. BUILDING NAME(S):
- 2. COUNTY: Steuben TOWN/CITY: Coming VILLAGE:
- 3. STREET LOCATION: 213 Pine Street
- 4. OWNERSHIP: a. public [] b. private [X]
- 5. PRESENT OWNER: Joseph D. and Genevieve Clancy ADDRESS:
- 6. USE: Original: Residence Present: Residence
- 7. ACCESSIBILITY TO PUBLIC: Exterior visible from public road: Yes [X] No []
 Interior accessible: Yes [] No [X] Explain: Private residence

CONTINUATION SHEET, Page 2
213 Pine Street
Corning, New York

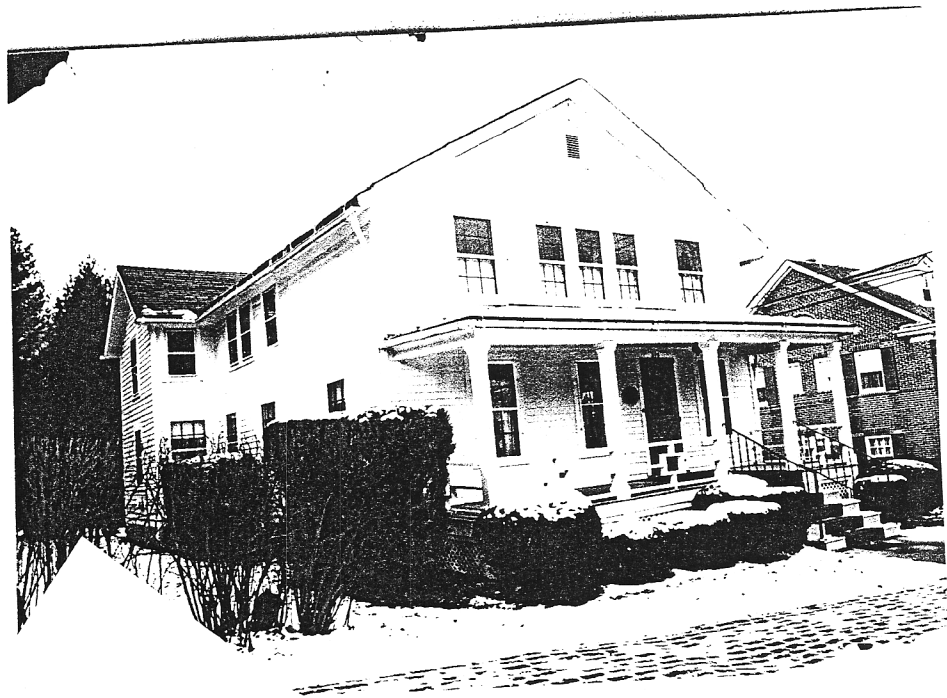
^ 213 Pine

The house consists of two cross-gabled sections and is clad in wood clapboarding. The foundation is parged and has basement level windows. The foundation of the front section of the house covered in a lattice-work skirt. The roof is covered in tiles. The front (east) facade has a gable-front and a one-story full-width porch. The porch is supported by five pier supports and features a wood porch rail with a square motif. A wrought iron railing leads up to the front stoop. This facade is four bays wide with the entrance in the third bay (working north). The three windows on the first level are all six-over-six-light double-hung sash. The second level contains Two six-over-six-light double-hung windows on either side of triple band of the same. The house has one visible central chimney. The west facade features a second level enclosed porch.

The south facade has an asymmetrical fenestration pattern making use of six-over-six-light double-hung sash in all cases. There are three windows on the first level of this facade, and three on the second level.
