BUILDING-STRUCTURE INVENTORY FORM

- 1. BUILDING NAME(S):
- 2. COUNTY: Steuben TOWN/CITY: Corning VILLAGE:
- 3. STREET LOCATION: 90 East Second Street
- 4. OWNERSHIP: a. public [] b. private [X]
- 5. PRESENT OWNER: Robert M. Campbell ADDRESS: 90 East Second Street, Corning, NY
Present: Residential
- 6. USE: Original: Single family residence
- 7. ACCESSIBILITY TO PUBLIC: Exterior visible from public road: Yes [X] No []
Interior accessible: Yes [] No [X] Explain: Private Residence

Continuation Sheet, Page 1
90 East Second Street
Corning, New York

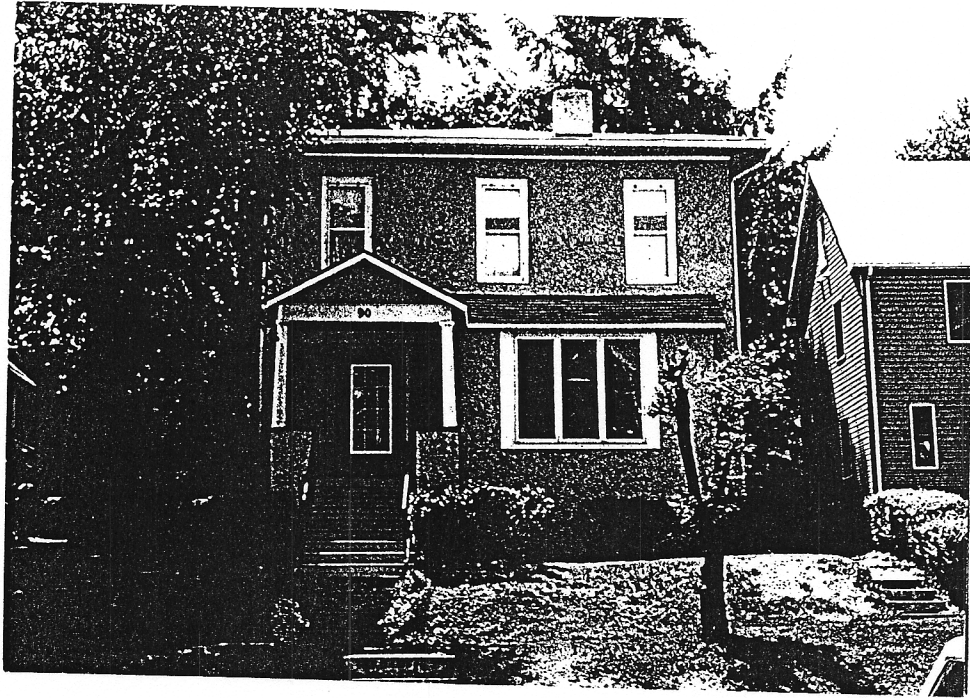
90 E. 2nd

^(south?) This house was originally a hip-roofed Italianate style building with a full-width porch and rear addition. ^{ped} The extensive alterations performed ca. 1917 ^{have made} changed the building ^{more stylistically similar to the style} into a fairly spare version of a Prairie Style house. The boxy shape of the Italianate ^{on} lent itself to the type of horizontally-oriented shed-dormered triple bays ^{appearance} that were added to the front and western ^{which} facades to give the building its Prairie style aspect. Modern metal-framed replacement windows in the bays have reduced their stylistic impact.

Other windows on the building are generally double-hung sash, ^{with} There are four-over-one sash on the secondary facades and one-over-one sash on the front of the house. The front entry ^{porch} is supported by two ^{tapered square} wood piers, and has a ^{enclosed} low solid balustrade ^{also} finished in stucco. The main ^{entry} entry

Single door is a three-panel door with a ^{single} ^{at the top} top light. There is also a two-story sun porch at the southeast corner of the house with wood shingle trim as a decorative accent, and another small rear porch.
