**BUILDING-STRUCTURE INVENTORY FORM**

ORGANIZATION (if any): Preservation Planning Workshop, Cornell University

- 1. BUILDING NAME(S):
- 2. COUNTY: Steuben TOWN/CITY: Corning VILLAGE:
- 3. STREET LOCATION: 16 East Third Street
- 4. OWNERSHIP: a. public [ ] b. private [X]
- 5. PRESENT OWNER: David Schirmer and Virginia Griffith ADDRESS: 16 East Third Street
- 6. USE: Original: Residence Present: Residence
- 7. ACCESSIBILITY TO PUBLIC: Exterior visible from public road: Yes [X] No [ ]  
Interior accessible: Yes [ ] No [X] Explain: Private residence

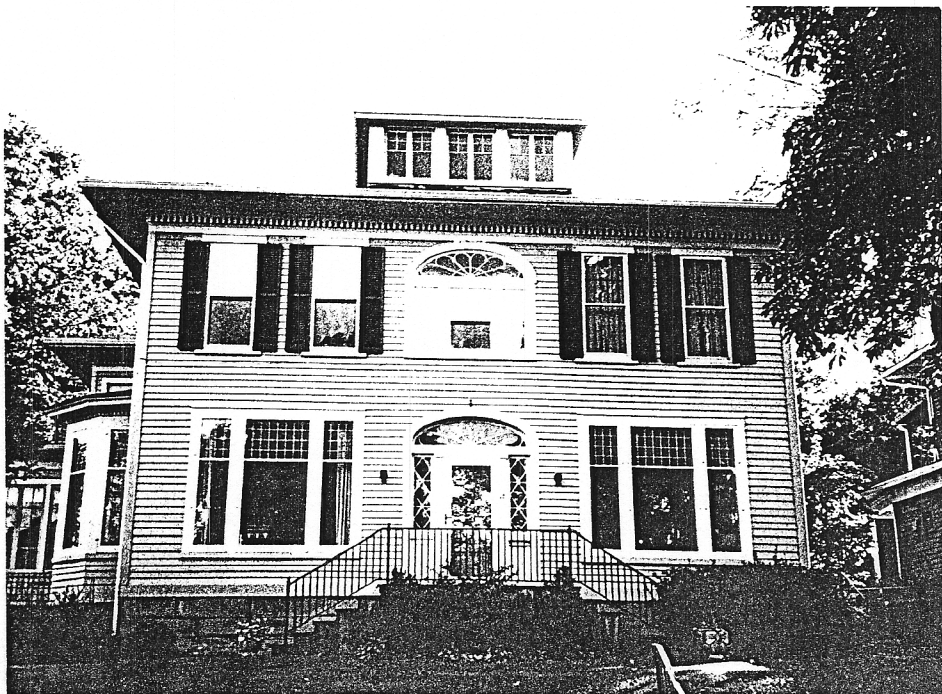
- 8. BUILDING MATERIAL: a. clapboard [X] b. stone [ ] c. brick [ ] d. board & batten [ ]  
e. cobblestone [ ] f. shingles [ ] g. stucco [ ] other:
- 9. STRUCTURAL SYSTEM: a. wood frame with interlocking joints [ ]  
b. wood frame with light members [X]  
c. masonry load bearing walls [ ]  
d. metal (explain)  
e. other
- 10. CONDITION: a. excellent [X] b. good [ ] c. fair [ ] d. deteriorated [ ]
- 11. INTEGRITY: a. original site [X] b. moved [ ] if so, when?  
c. list major alterations and dates (if known): See Continuation Sheet
- 12. PHOTO:
- 13. MAP:
