**BUILDING-STRUCTURE INVENTORY FORM**

ORGANIZATION (if any): Preservation Planning Workshop, Cornell University

- 1. BUILDING NAME(S): \_\_\_\_\_
- 2. COUNTY: Steuben TOWN/CITY: Corning VILLAGE: \_\_\_\_\_
- 3. STREET LOCATION: 82 East Third Street
- 4. OWNERSHIP: a. public [ ] b. private [X]
- 5. PRESENT OWNER: Allan B. and Linda Hansee ADDRESS: 82 East Third Street  
Present: Residence
- 6. USE: Original: Residence Exterior visible from public road: Yes [X] No [ ]
- 7. ACCESSIBILITY TO PUBLIC: Interior accessible: Yes [ ] No [X] Explain: Private residence

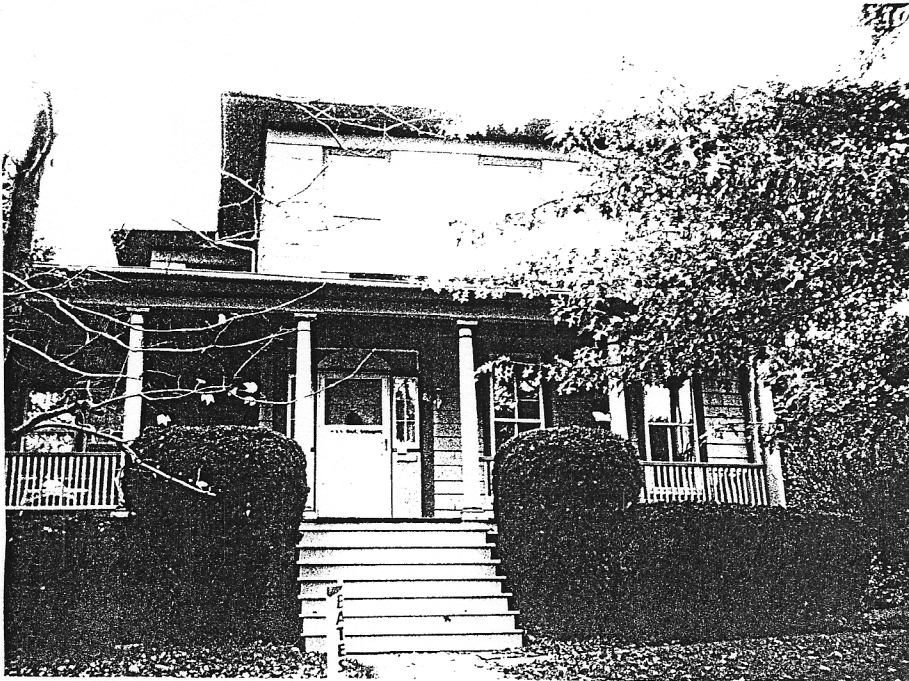
The Italianate plan of 82 East Third Street is basically rectangular, with an eastern two-story projection, a western one-story bay window, and a rear addition to the south facade. The front (north) facade of the house consists of three (on the second story level) elongated, two-over-two, double hung windows. There are two additional two-over-two windows on the first story as well as a wood panelled door on the east side of the projecting front facade. The

house is constructed with a low hipped asphalt roof, and boasts a wide, over hanging eave void of brackets.
