BUILDING-STRUCTURE INVENTORY FORM

- 1. BUILDING NAME(S):
- 2. COUNTY: *Steuben* TOWN/CITY: *Coming* VILLAGE:
- 3. STREET LOCATION: *128 Wall Street*
- 4. OWNERSHIP: a. public [] b. private [X]
- 5. PRESENT OWNER: *Early Gerald* ADDRESS: *222 Park Ave., Coming*
- 6. USE: Original: *Residential* Present: *Residential*
- 7. ACCESSIBILITY TO PUBLIC: Exterior visible from public road: Yes [X] No []
Interior accessible: Yes [] No [X] Explain: *Private Residence*

Continuation Sheet, Page 2
128 Wall Street
Corning, New York

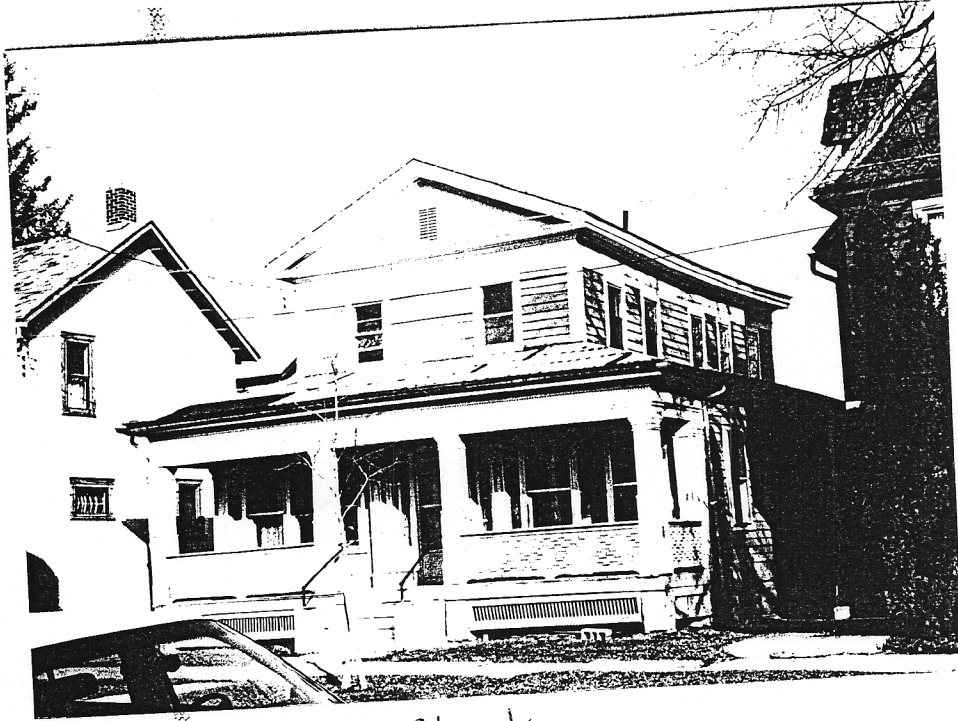
128 Wall Street

This is a central rectangular box with Federal-style and Greek Revival-style features, such as the wide cornice, pedimented gable ends and recessed entry door with sidelights and toplight. It had a one-story addition attached to its (now) east facade. A full-width, one-story porch covers the west (now front) symmetrical facade. The porch has a shallow-pitched, hipped roof and a broad cornice supported by square piers on paneled bases. Patterned shingles are used to form a balustrade between the porch piers. The house itself has a low-pitched gable roof and clapboard siding. Other important features are the wide windows with one-over-one double-hung sash.
