# BUILDING-STRUCTURE INVENTORY FORM

ORGANIZATION (if any): Preservation Planning Workshop, Cornell University

1. BUILDING NAME(S):
2. COUNTY: Steuben                      TOWN/CITY: Corning                      VILLAGE:
3. STREET LOCATION: 209 Wall Street
4. OWNERSHIP:                      a. public [ ]    b. private [X]
5. PRESENT OWNER: John and Katherine Broderick                      ADDRESS: 209 Wall Street  
Present: Residence
6. USE: Original: Residence
7. ACCESSIBILITY TO PUBLIC:                      Exterior visible from public road: Yes [X] No [ ]  
Interior accessible: Yes [ ] No [X] Explain: Private residence

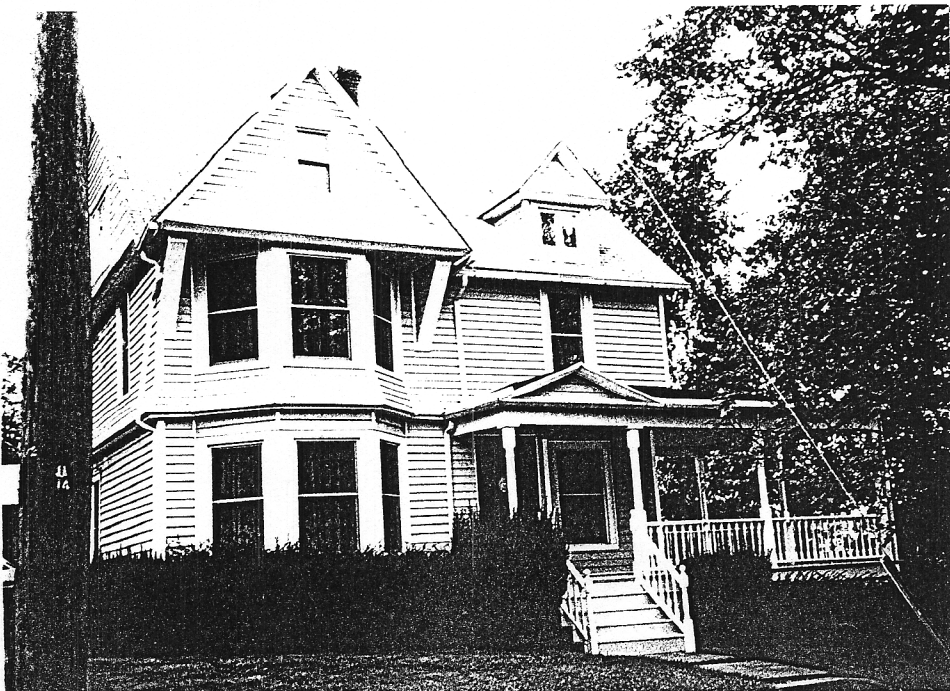
The plan of 209 Wall Street is basically square, with a two-story front bay window, and a one-story front/side porch. The steeply pitched roof of 209 Wall Street is the most prominent feature indicative of the Queen Anne Style. The asphalt shingled roof is dominated by a main gable constructed with a north/south orientation, intersected by a series of cross gables. A two-story bay window is constructed on the southern portion of the east facade, consisting of six one-over-one, double-hung sash. The bay window is centrally interrupted where the upper portion is canted outward, and overhangs the lower portion. This is a device used to create lively facade, where the Queen Anne Style attempts to avoid smooth facades. Crowning the bay window, an intersecting gable supported by encased brackets projects even further over the window. The clapboarded gable-end contains one small one-over-one window. The roof of the northern portion of the front facade consists of a dormer window finished with a small clapboarded gable-end, and installed with two small single paned sash. On the second story below the dormer window, there is a single one-over-one, double-hung window which is located above a larger one-over-one, double hung window. The front entry door is located to the south of the first story window. A one-story, skirted porch wraps around from the east to the north facade, and is detailed with a spindlework balustrade and stair handrail, spindlework porch supports, and a small clapboarded pediment which crowns the porch entryway. The north and south facades are constructed with projecting, sloping overhangs between stories, ending with a projecting gable end. The clapboarded gable ends are installed with a central tripartite sash. The second story of the north and south facades is installed with two one-over-one, double-hung sash which are located towards each end of the house.
